CRASH INJURY BULLETIN

PART I ATTACHMENT OF SEAT BELTS IN THE HU-1A HELICOPTER

PART II STOWAGE OF EQUIPMENT UNDER TROOP SEATS

TREC Technical Report 60-61

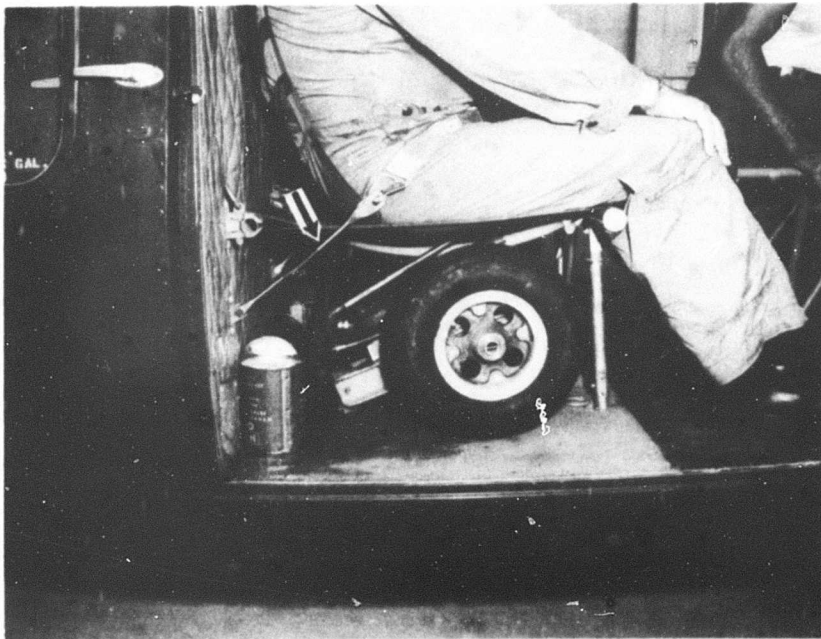
The photographs on page 2 (Figures 1 and 2) depict the correct and the incorrect manner of attaching the safety belts in the HU-1A helicopter. The most desirable installation is illustrated in Figure 1.

To fully utilize the skeletal strength of the human body, the seat belt should pass across the hips at approximately 45° to the longitudinal axis of the airplane as illustrated in Figure 1. When restrained by a seat belt only, which is common in the cabin area, the occupant's body will flex over the seat belt during a forward deceleration. If this flexing of the body occurs at the lumbo-sacral joint, the strain on the spine will be minimal.

Figure 1. The correct manner in which the safety belt should be installed in the HU-1A is depicted by the arrow. Note that the belt crosses the hips at approximately 45°.

Attachment of the safety belts to the cables as illustrated in Figure 1 reduces the possibility of spinal or internal injuries to the occupants involved; reduces the possibility of rear longitudinal seat support failures; and provides for greater restraint for the occupant since these cables are anchored to primary structure.

Based on the foregoing, it is recommended that a bulletin be issued, specifying that the proper attachment (cables) be used for the safety belts in the cabin of the HU-1A.

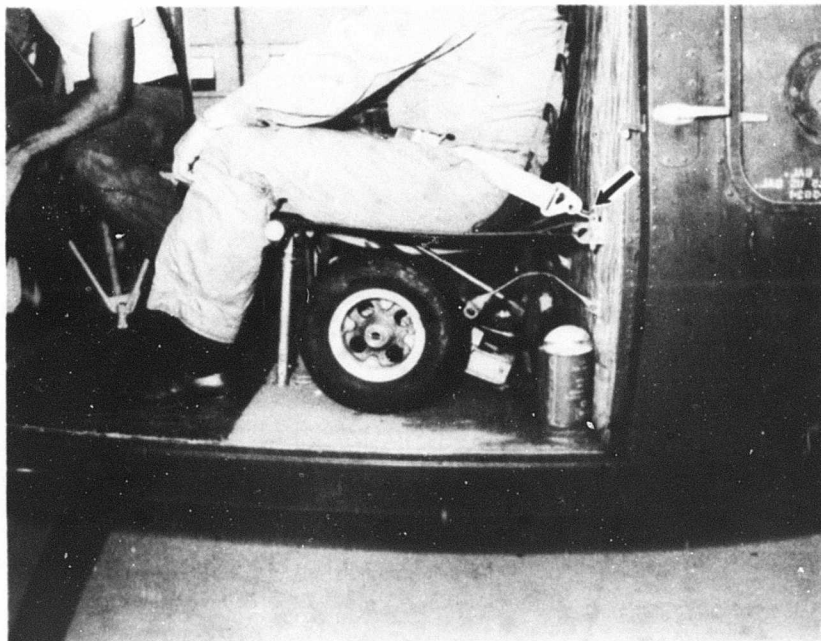
When the safety belt is attached to the "O" ring, (Figure 2) the spine is forced to bend or flex at a much higher level which often causes flexion fractures of the spine.

The incorrect belt installation permits the safety belt to "ride up" and could cause rib and/or chest injuries due to flexing over the belt buckle, in addition to possible spinal injuries.

Figure 2. The incorrect method of attaching the safety belt to the "O" ring is depicted by the arrow. Note that the belt crosses the occupant at approximately 90°.

The attending doctor stated that he felt the injuries to the chest, lower rib cage, and lumbar spine were due to the safety belt not being properly positioned over the hips. This statement was substantiated during an interview with the occupant, during which he stated the safety belt kept "sliding up".

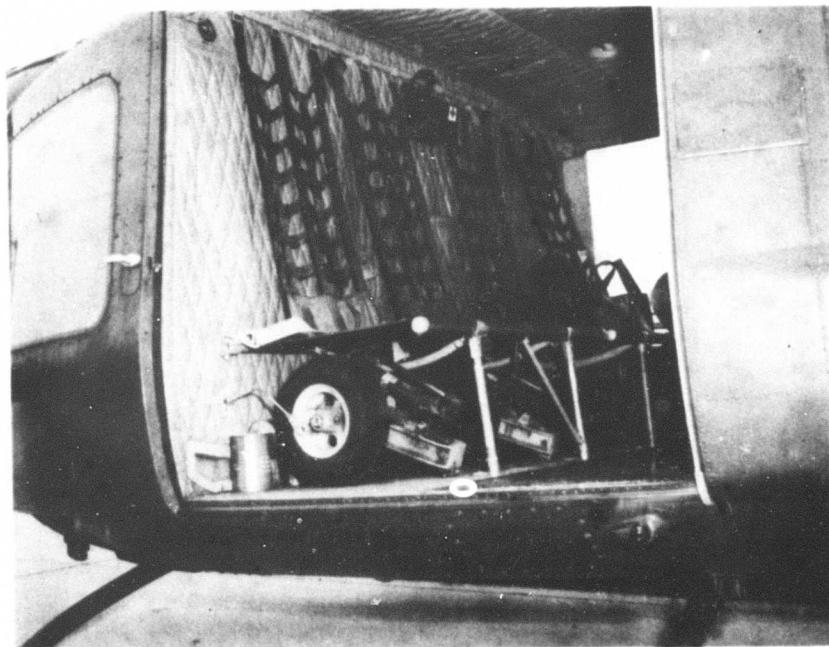
Figures 3 and 4 illustrate the area under the seat which is used as a "catch all" for the ground handling wheels, oil cans, tool boxes, main rotor tie-down, litter attachments, and other loose equipment carried in the aircraft. These photos were taken of an aircraft selected at random.

Accident experience with the type troop seat utilized in this aircraft indicates the seat will fail under even moderate crash load conditions. It is, therefore, important that the area directly beneath all occupied troop seats be kept free of loose equipment such as illustrated in Figures 3 and 4.

Figure 3. Over-all view depicting the large assortment of items placed beneath the seat.

Based on the foregoing, it is recommended that a bulletin be issued specifying that the area beneath all occupied troop seats be kept free of loose equipment. Further, if equipment has to be carried under unoccupied troop seats, it should be of a non-rigid type and securely anchored to prevent it from becoming a missile in the event of a forward deceleration.

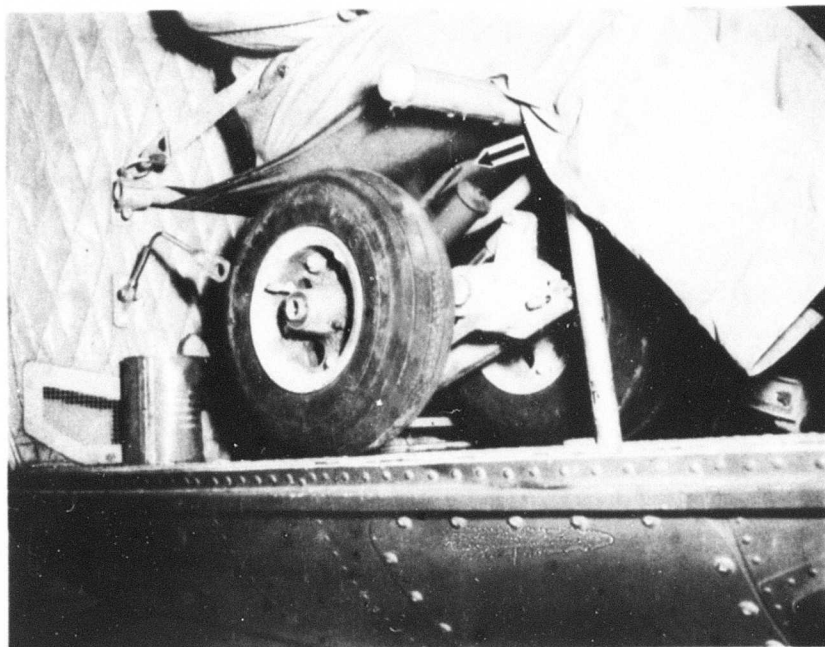
Figure 4. Close-up of the ground handling wheels stored beneath the seat. Note the position of the hand pump lever (arrow).

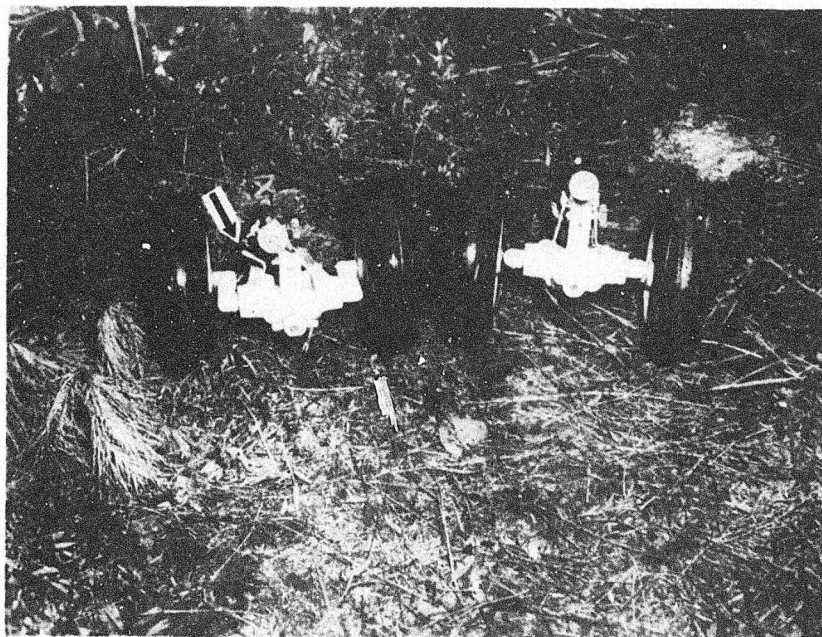
Figure 5 depicts an accident showing the wheels stowed beneath the seats. The occupant of this seat sustained painful buttock injuries and tenderness in the lumbar spine area as a result of bottoming out and striking the ground handling wheels with sufficient force to break the castings (arrow - Figure 6) at the top of the wheel assembly.

Figure 6. The arrow depicts the broken casting on the ground handling wheels. Note the amount of downward deflection as opposed to the intact set on the right.
